# Manhole Inspection Summary

Manhole # S49M\_\_029MH

Insp Date: **12/3/08 10:24 AM**

**Location** Address: **2429 boston st**

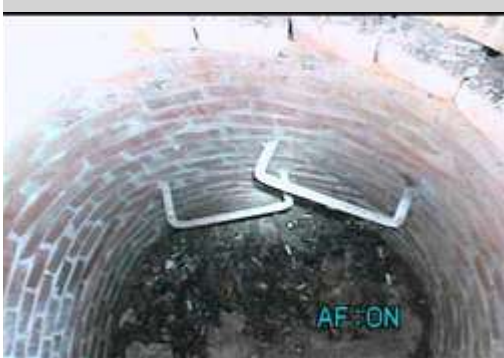
Miscellaneous

upper set of steps

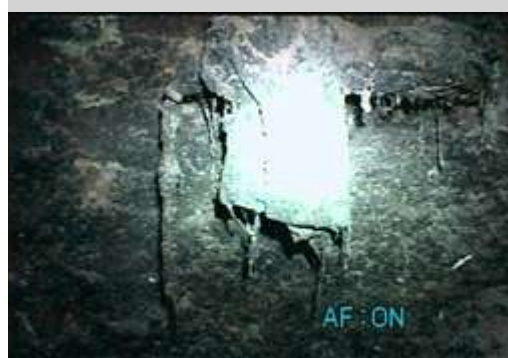
Defect 6

☒ **Evidence Of Surcharge** Depth: **7.** (ft.) ☐ Active Surcharge Present

surcharge evd

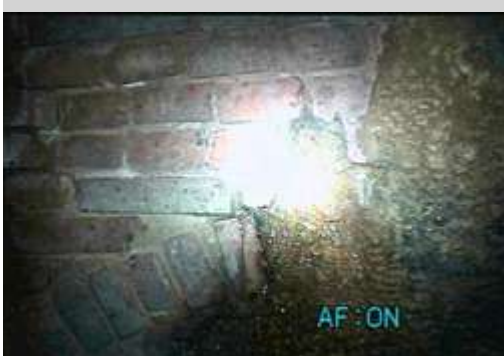
Defect 5

Infiltration: ☐ None ☐ Joint ☐ Cracks ☐ Mortar ☐ Roots ☒ **Wall**

barrel infiltration

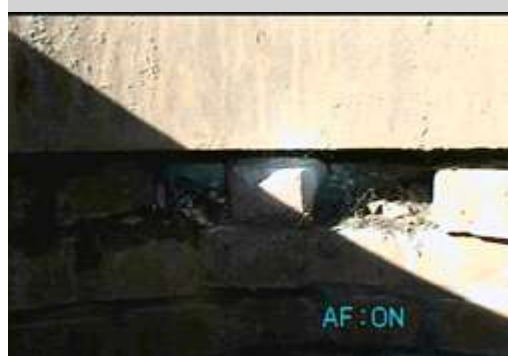
Defect 4

Condition: ☐ Sound ☐ Cracked ☐ Root Intrusion ☒ **Loose Brick** ☒ **Deteriorated**

frame adj loose bricks, deteriorated

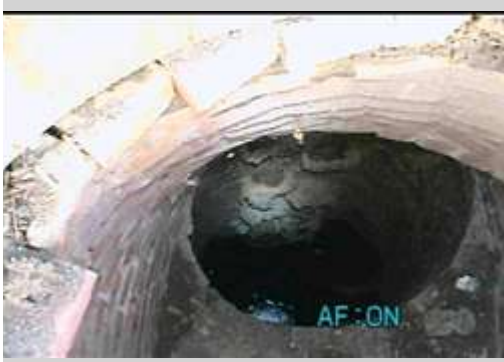
Defect 2

Count: **11** Missing: **0** ☒ **Corroded**

corr steps

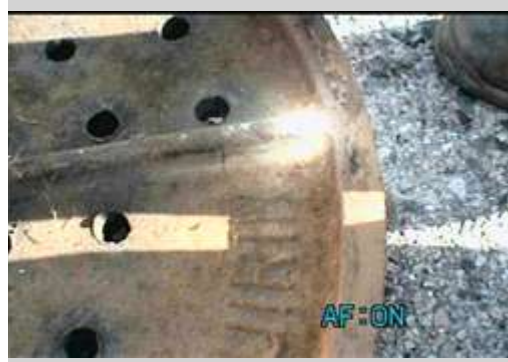
Defect 1

Condition: **Cracked**

cracked cover

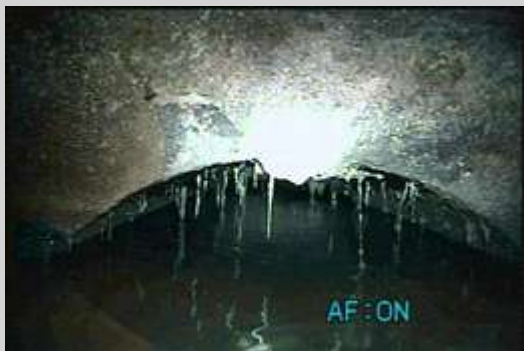
6 O'Clock Inflow

best shot high flow
